HYDROGRAPHIC SYSTEMS READINESS REVIEW

NOAA Ship NANCY FOSTER

2006

This report, which is a hybrid of a hydrographic systems readiness review package and a data acquisition & processing report, serves two purposes: (1) to document the configuration and calibration of the overall multibeam system, including supporting equipment, and (2) assess the ability of the multibeam system to meet OCS hydrographic surveying requirements.

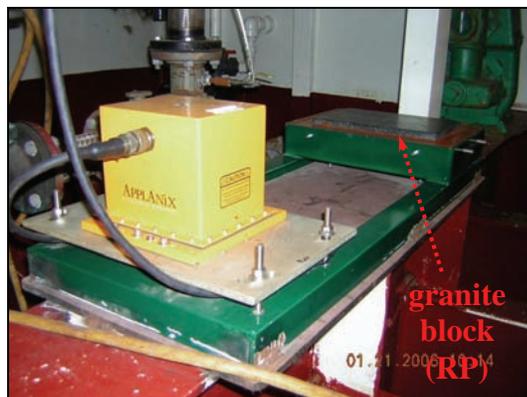
Figure 4: *POS/MV IMU and Granite Block Mount*

NANCY FOSTER is equipped with an Applanix Model 320 Version 4 POS/MV, with an ancillary Trimble DSM 132 antenna that supplies Coast Guard differential GPS correctors. Whereas the POS/MV is configured via the POS/MV controller software installed on the HYPACK acquisition computer, the Trimble DSM 132 is configured via the controls on the front of the receiver. The system's Inertial Measurement Unit (IMU) is located in the sonar void, within very close proximity of the granite block (see Appendix 2 for the lever arm). The ancillary Trimble DMS 132 antenna is mounted between the primary and secondary POS/MV antennae, which are mounted on the fore and aft ends, respectively, of a mounting bracket installed over the port-side railing of the flying bridge. The IMU and antenna installations are shown in figure 4 and 5, respectively. The two POS/MV antennae and the DMS 132 were not installed on the main mast because the mast vibrates noticeably when the ship is underway.

The primary antenna-to-granite block and IMU-to-granite block offsets are entered into the POS/MV controller software so that the position output by the POS/MV is the position of the granite block. Also entered into the POS/MV configuration is the granite block-to-center of roll and pitch lever arm. The offset between the granite block and the EM 1002 transducer is accounted for in the EM 1002 installation parameters. For other POS/MV controller parameters, including heave filter settings and serial port settings, refer to Appendix 6, POS/MV Configuration Report. Position and attitude data from the POS/MV are inputted directly at the EM 1002 processing unit (PU).

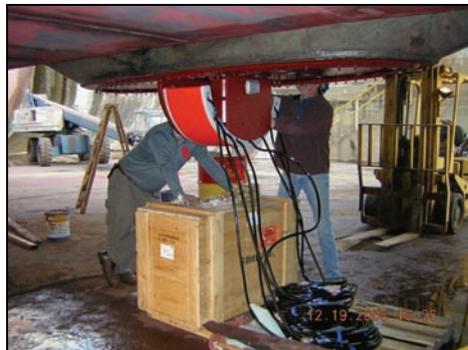
Figure 10: *Image of EM 1002 Transducer Mount*

NANCY FOSTER is equipped with a hull-mounted Kongsberg EM 1002 multibeam echosounder, which is installed between two fiberglass hydrodynamic fittings near frame 25 (see figures 10 and 11 below). The EM 1002 is a 95-kHz system with a 150° swath consisting of 111 individually-formed 2° beams.
